Overcoating of Lead-Based Paint on Steel Structures

Cost and Performance Report

Timothy D. Race, Ashok Kumar, Robert A. Weber,
and L.D. Stephenson

March 2003

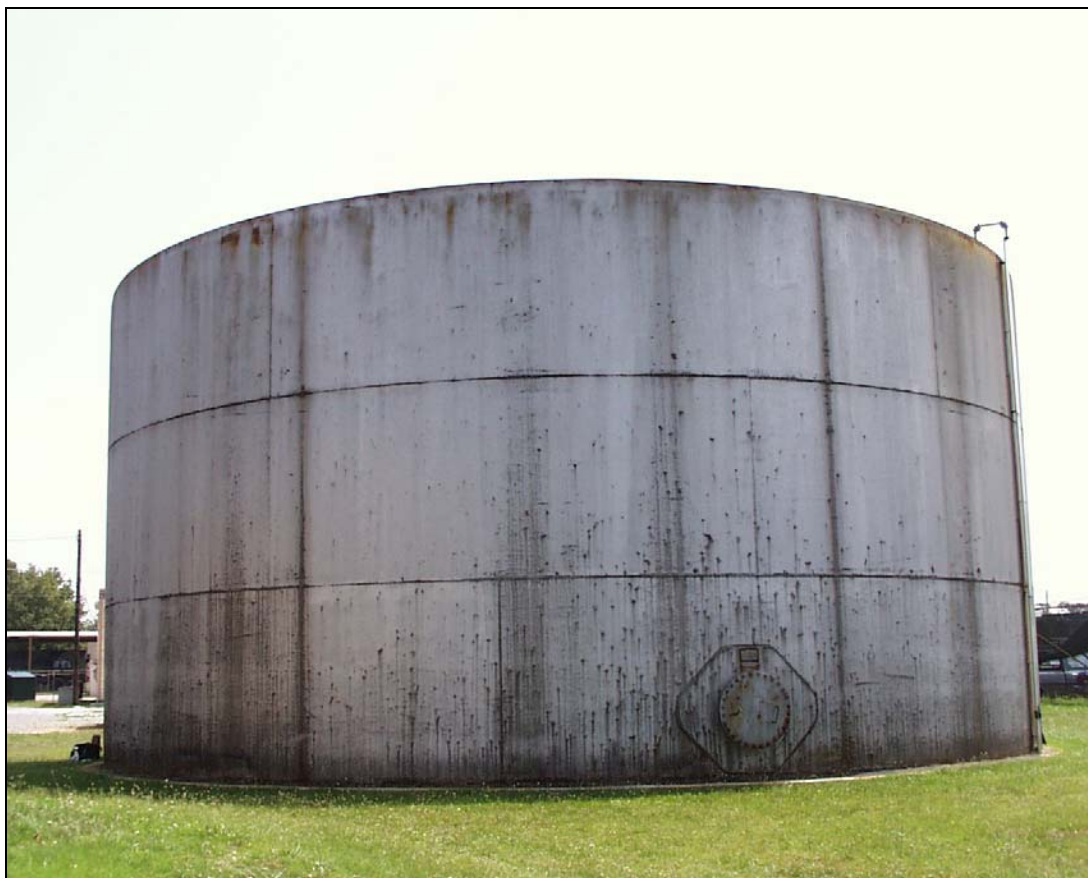
A visual inspection and physical tests were performed on the existing aged coating. Dry film thicknesses (DFTs) were measured at eight locations. The average thickness ranged from 2.0 to 4.1 mils. The overall average thickness is approximately 3.0 mils. Three adhesion measurements were taken, two with a south solar orientation and one with a north solar orientation. Crosscut adhesion values (ASTM D 3359 Method A) were 3A and 5A (south facing) and 3A (north facing), indicating slightly degraded intercoat adhesion.

Rusting ranged from 3 to 5 percent of the tank surface. Corrosion was primarily general spot corrosion with associated staining. The north side and lower portions of the tank were somewhat more degraded than the upper portions and south side. However, the rust distribution was fairly uniform overall.

Based on the generally low DFT and overall appearance, the tank has probably never been maintained or recoated.

Figure 1. Fort Campbell water tank prior to cleaning and overcoating.

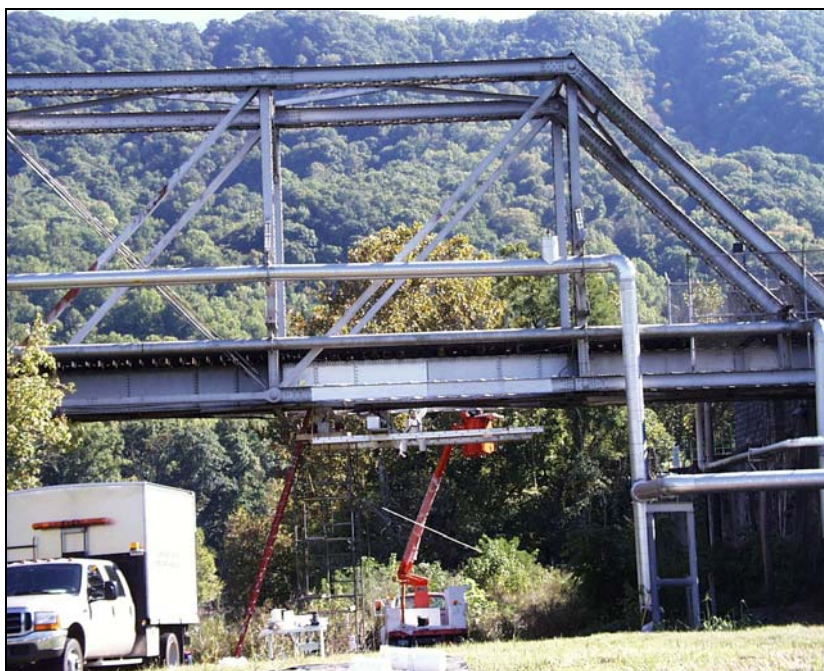
A visual inspection and physical tests were performed on the aged coating. The bridge appears to have been touched up and repainted on numerous occasions. It is doubtful that the bridge has been abrasive blasted and painted in at least the last 30 years and possibly not since it was erected at HAAP in 1943. The paint system is comprised of an orange primer and aluminum topcoat, which are probably TT-P-86, Type I, red lead in linseed oil and TT-P-38, aluminum phenolic finish coat. Most of the touchup painting was done with an aluminum finish coat. Paint film thicknesses are generally 8 to 15 mils on flat vertical surfaces and 20 to 25 mils on upward facing horizontal surfaces. The amount of visible rust is less than 1 percent of the total test area. Most of the rust was on the tops of flanges. Some rusted areas on the flanges were previously coated over and were lifting and curled. Adhesion tests were performed in accordance with ASTM D 3359 Method A X-cut tape test. Adhesion ranged from 4A to 5A. In some cases, a thin layer of aluminum pigment was lifted with the tape. This nonadherent material is the equivalent of chalk in a standard pigmented coating. A good deal of dirt had also accumulated on many of the bridge components.

Figure 2. Railroad bridge at HAAP, TN, with overcoated test areas.

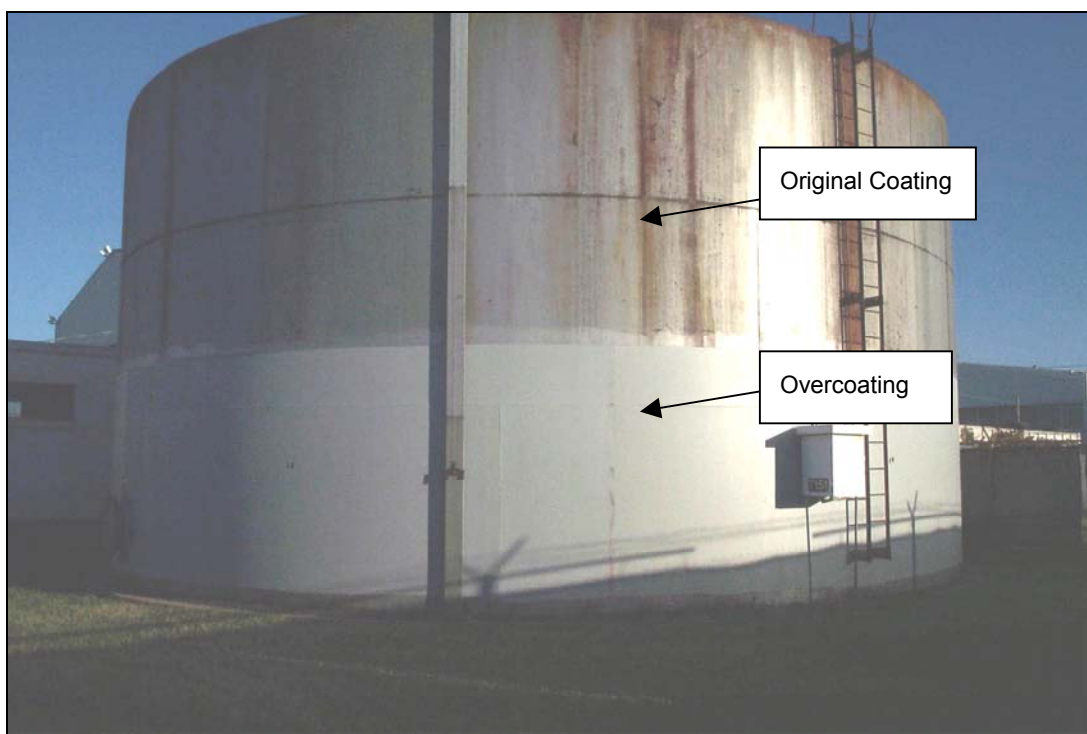
Figure 3. Deluge tank at Fort Campbell Army Airfield. (Original coating with lead-based paint primer visible at top is deteriorated and steel underneath is rusted. The tank was overcoated with test patches of moisture cure polyurethane in October 2000.)

Wasser Mio Aluminum primer, Ferromastic intermediate, and Ferrox A topcoat were applied by brush and roller to the first test area. Sherwin-Williams Corothane I Mastic primer, Corothane I Ironox A intermediate, and Corothane I Ironox A topcoat were applied by brush and roller to the second test area. Figure 3 shows the deluge tank after overcoating with test patches of moisture cure polyurethane.

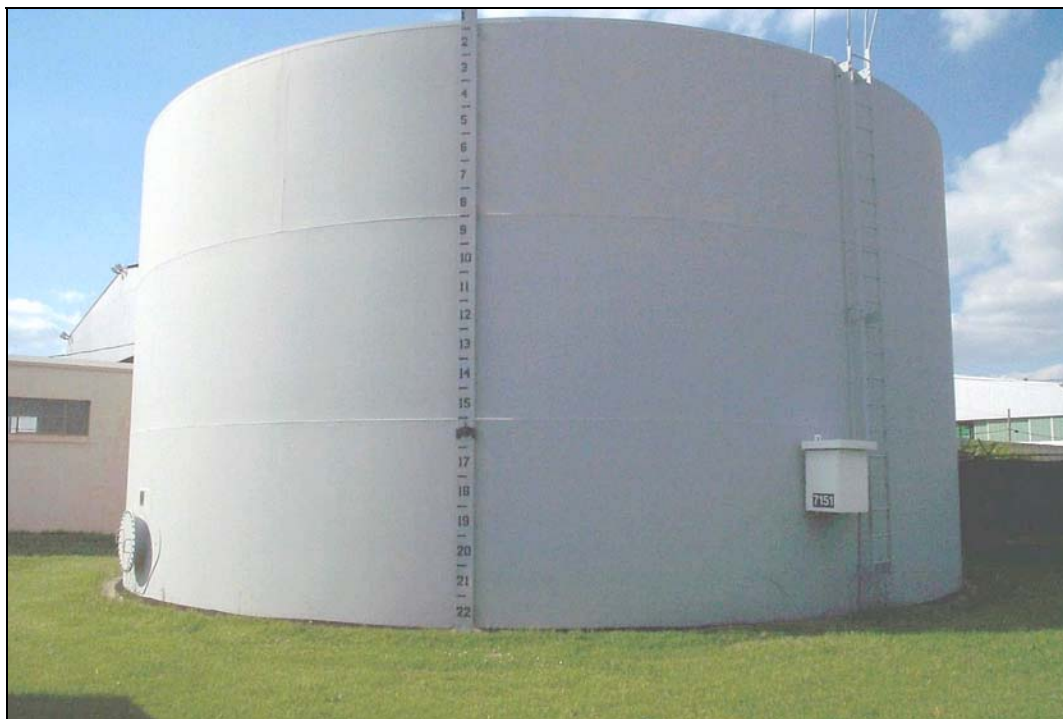
Figure 4. Deluge tank at Fort Campbell Army Airfield after overcoating completed in August 2001.

After evaluation of the two coating systems, the coating system composed of Sherwin-Williams Corothane I Mastic primer, Corothane I Ironox A intermediate, and Corothane I Ironox A topcoat was chosen for completion of the tank coating job, as shown in Figure 4. The projected life of the overcoat repair on this tank is 15 to 25 years. This projection is based on the pre-overcoat condition of the original paint system, the durability of the overcoat materials, and the severity of the exposure environment. It should also be noted that the water tank can probably be overcoated two more times provided its condition is not allowed to deteriorate past that which is suitable for overcoating.
